## A Survey of Thatched Buildings in Scotland

Thatch Survey of Scotland  
2014-15

A photographic survey of thatched buildings in Scotland, surveyed between May 2014 and August 2015 by Zoe Herbert (SPAB Scotland Officer), on behalf of the Society for the Protection of Ancient Buildings.

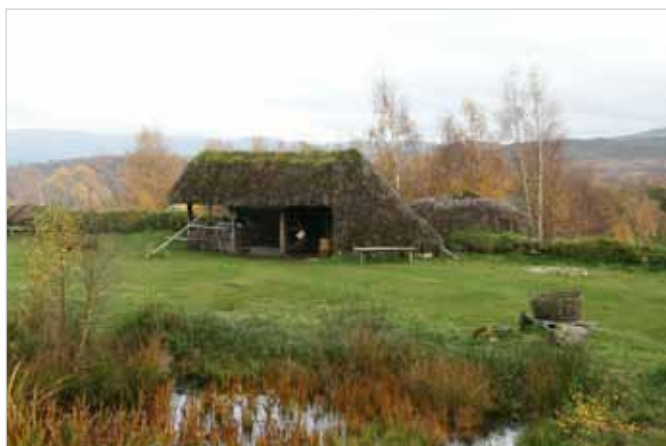
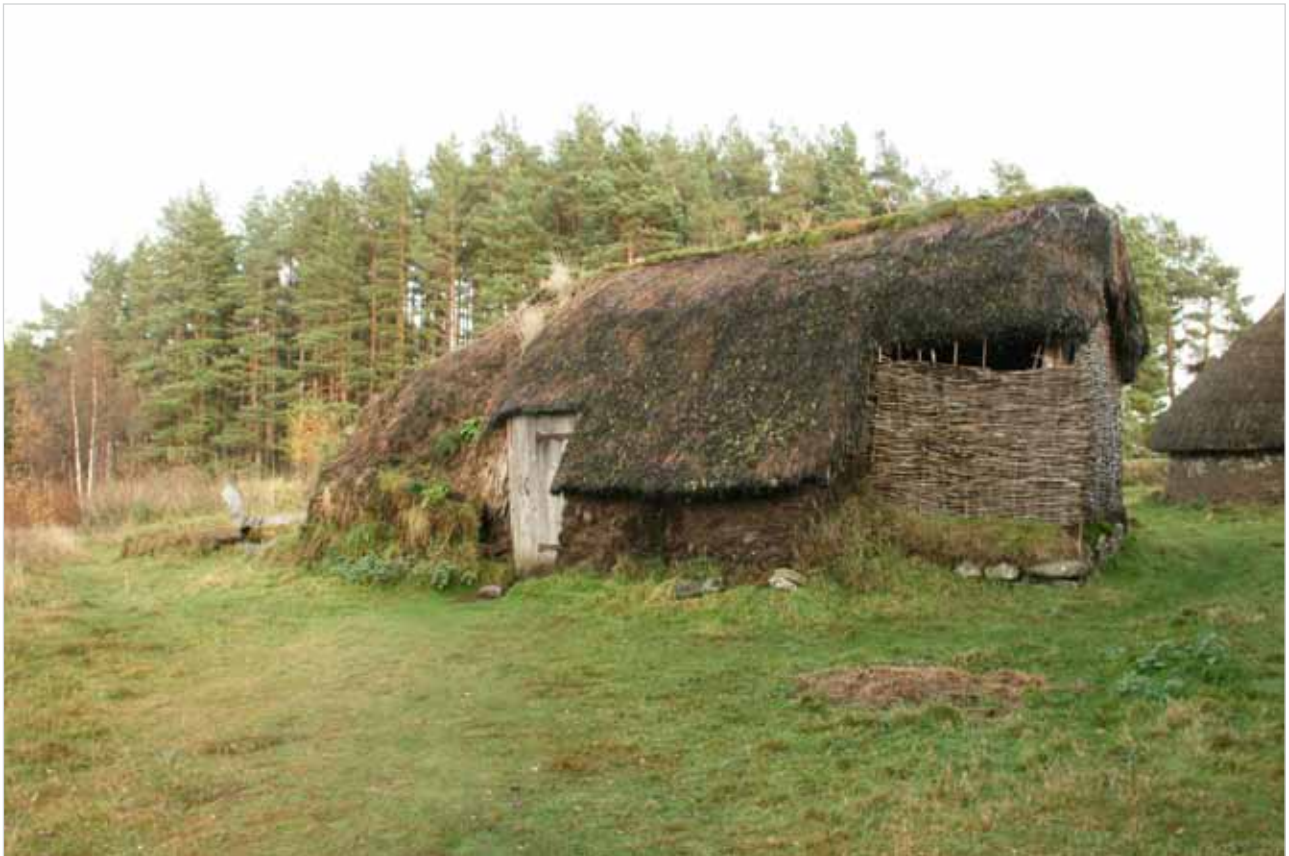
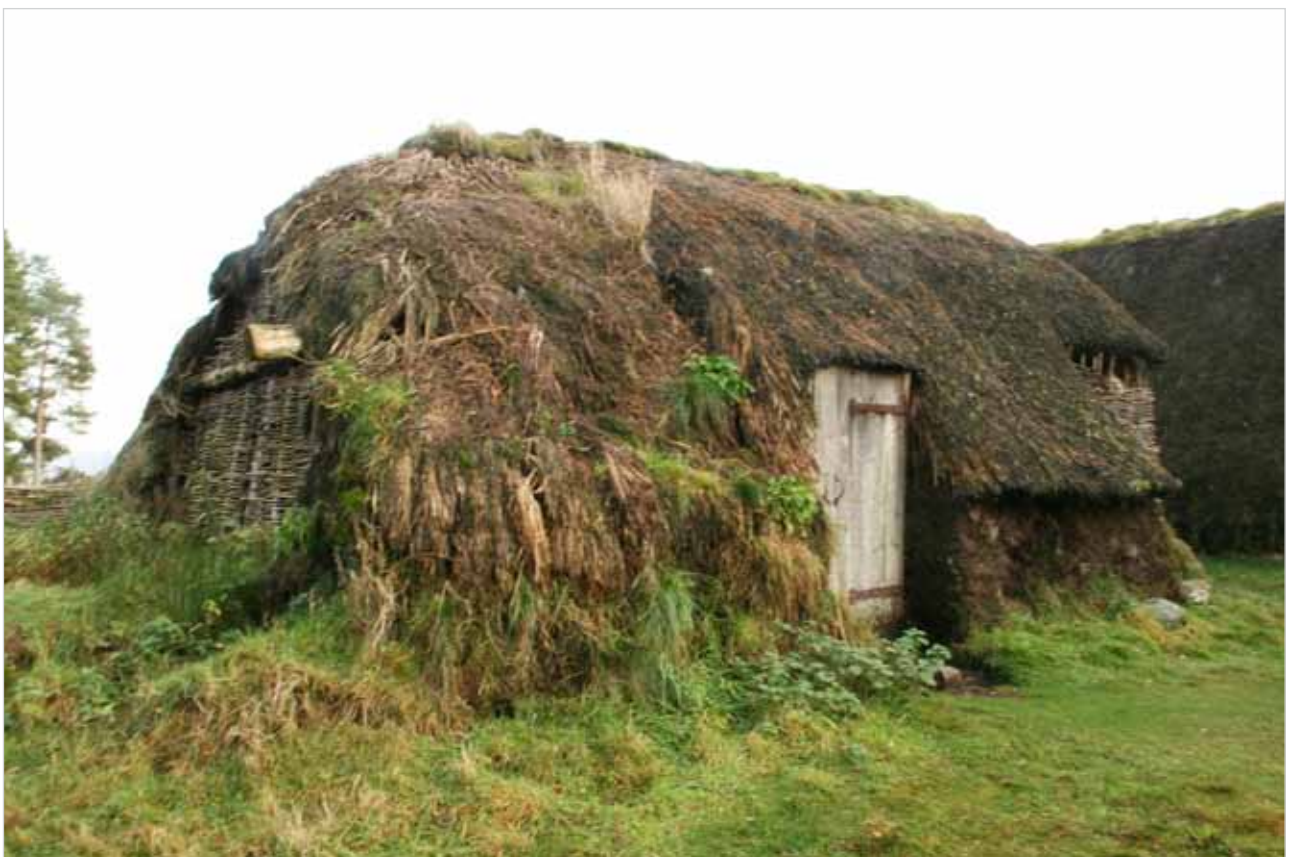
Bairns Barn – Highlands

Additional Notes: ..... Part of a reconstruction at the Highland Folk Museum of an early 1700s Highland township. This building is used for children's activities in the township, and has a thatched barn used for storage and amenities behind it that is not open to the public. Both roofs are thatched in heather and have a turf ridge, and both have been left uncovered. There is a small amount of mossy vegetation growth across the surface of the thatch throughout.

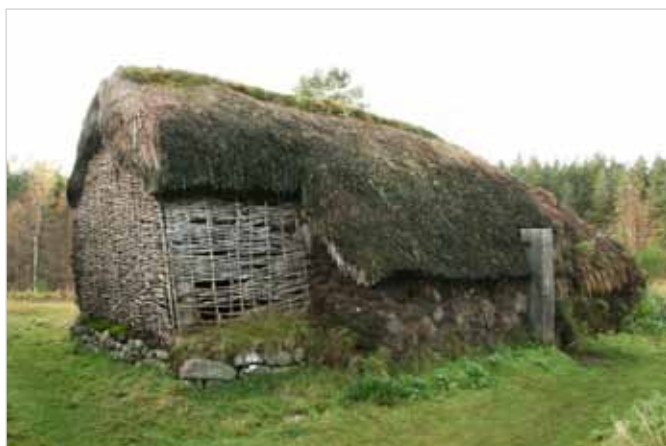
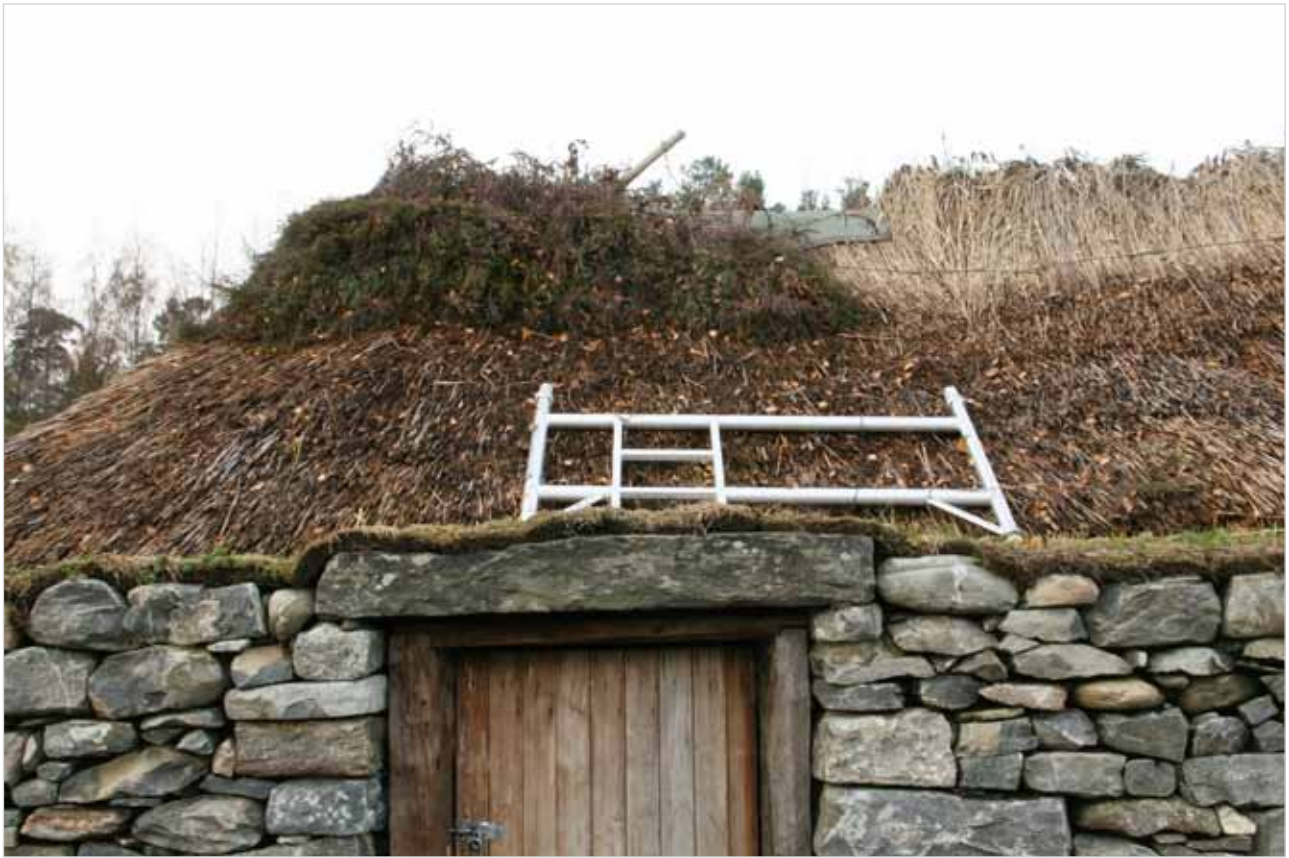
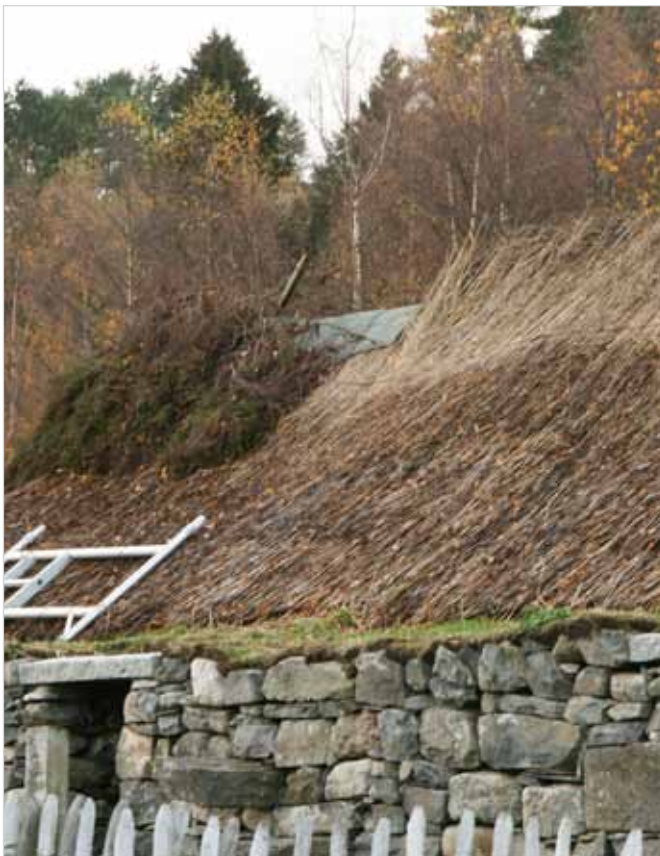
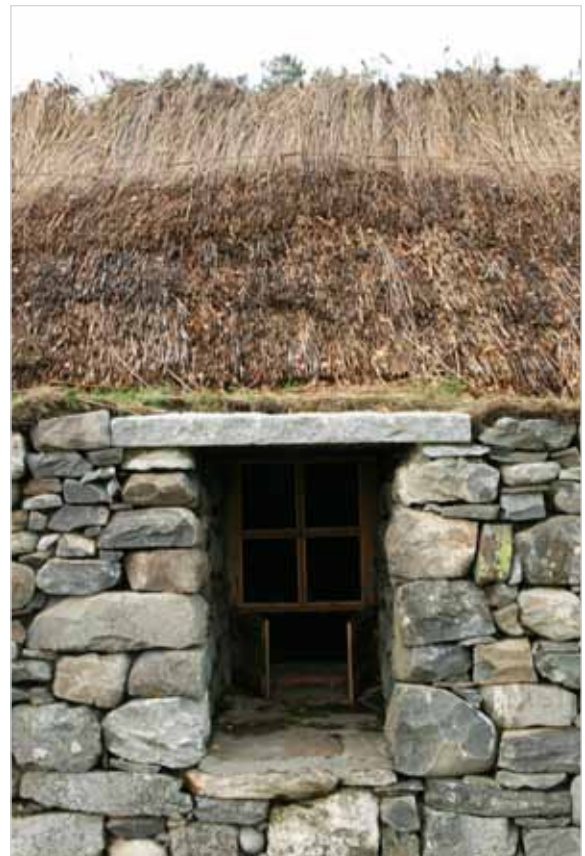
Barn – Highlands

..... The roof is thatched in predominantly bracken and has a turf-thatched ridge. The roof has been left uncovered and has some mossy and grassy vegetation growth across the surface of the thatch throughout. The thatch at the north end of the building is in a poorer condition than the south end and has some small areas of thatch missing and substantially more vegetation growth.

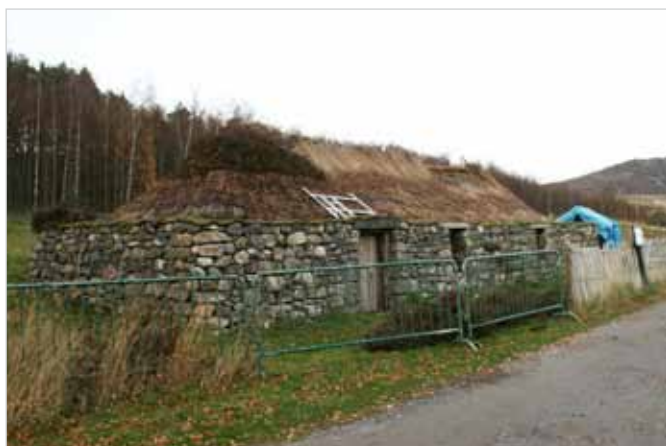
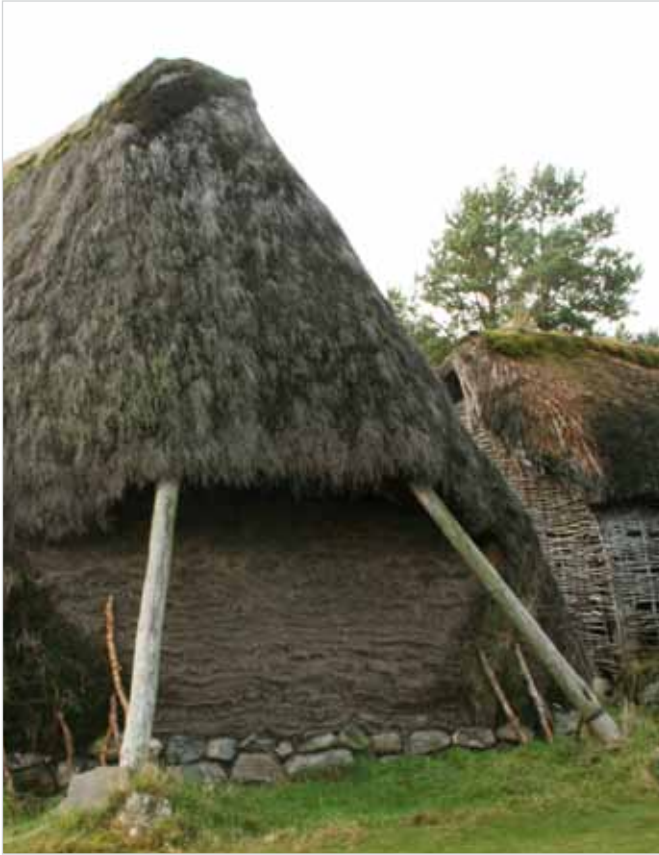
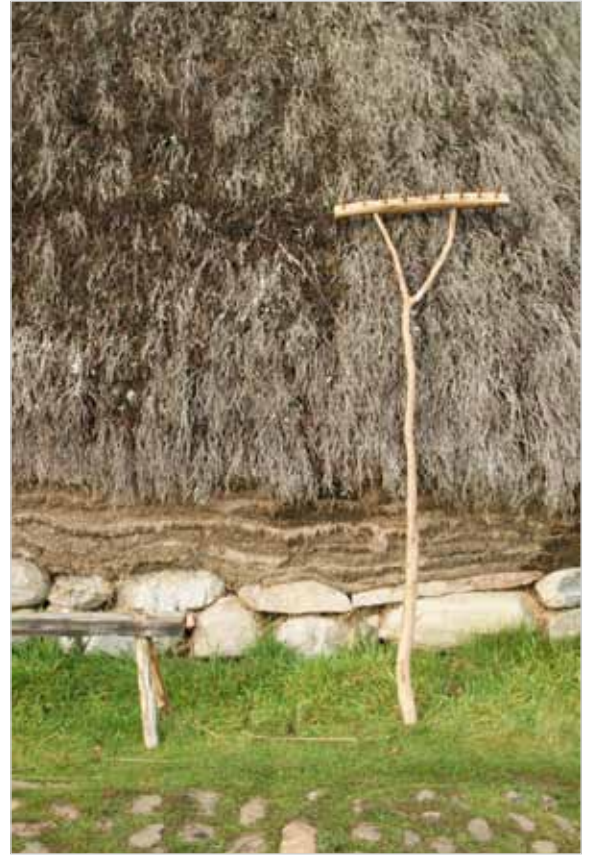
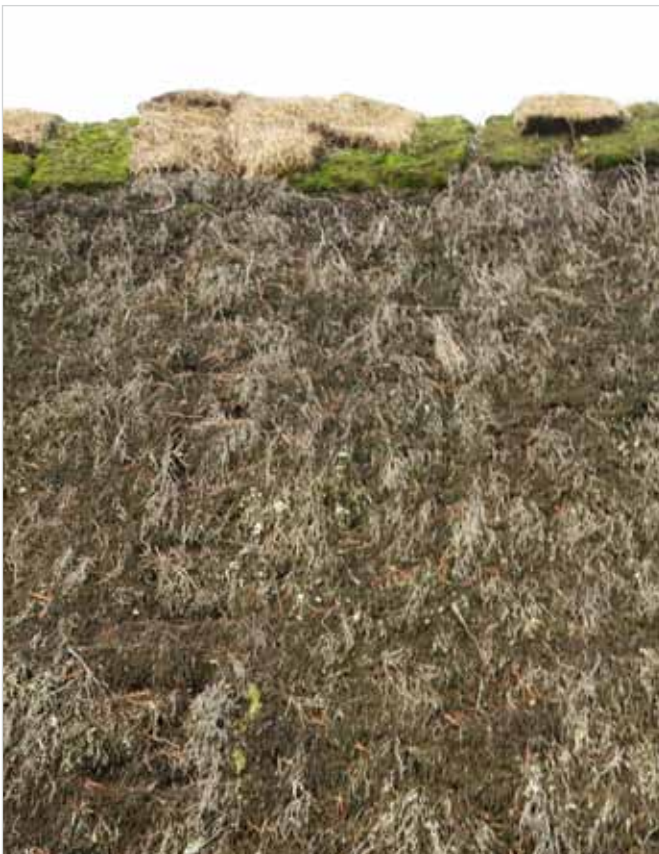
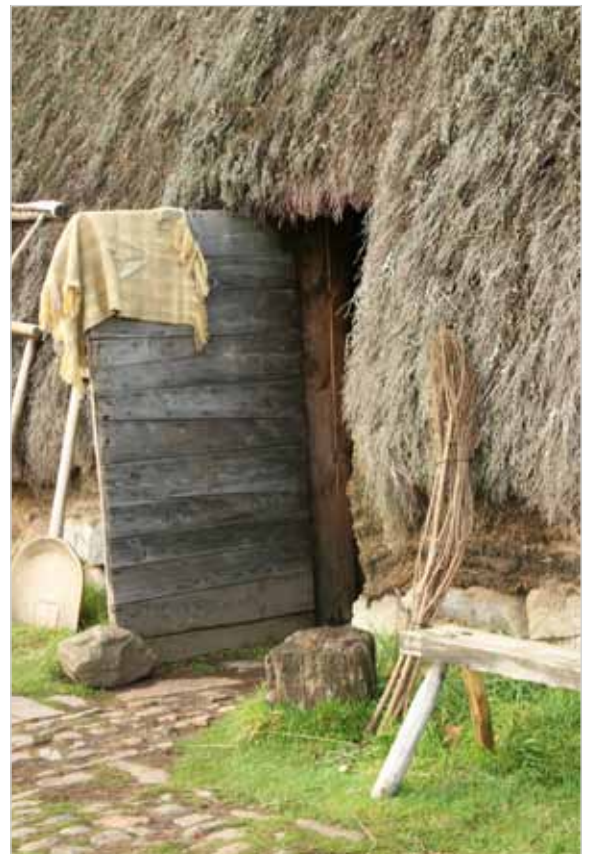
The Blackhouse – Highlands

Additional Notes: ..... Reconstruction blackhouse from the Isle of Lewis, built in the 1940s in the nearby Kingussie museum site. The building was taken down and re-erected in Newtonmore in 2013 as part of the amalgamation of the Highland Folk Museum's two sites. The building is currently closed to public access and is in the process of being re-thatched. There is a base layer of what appears to be rush, with the beginnings of a layer of heather around the top. The ridge is not yet in place and it is unknown what material is to be used for this. The building currently has an exposed wallhead, upon which a thin layer of turf has been placed.

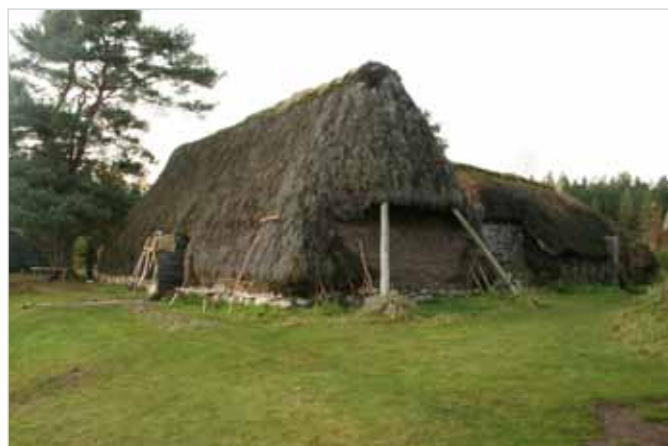
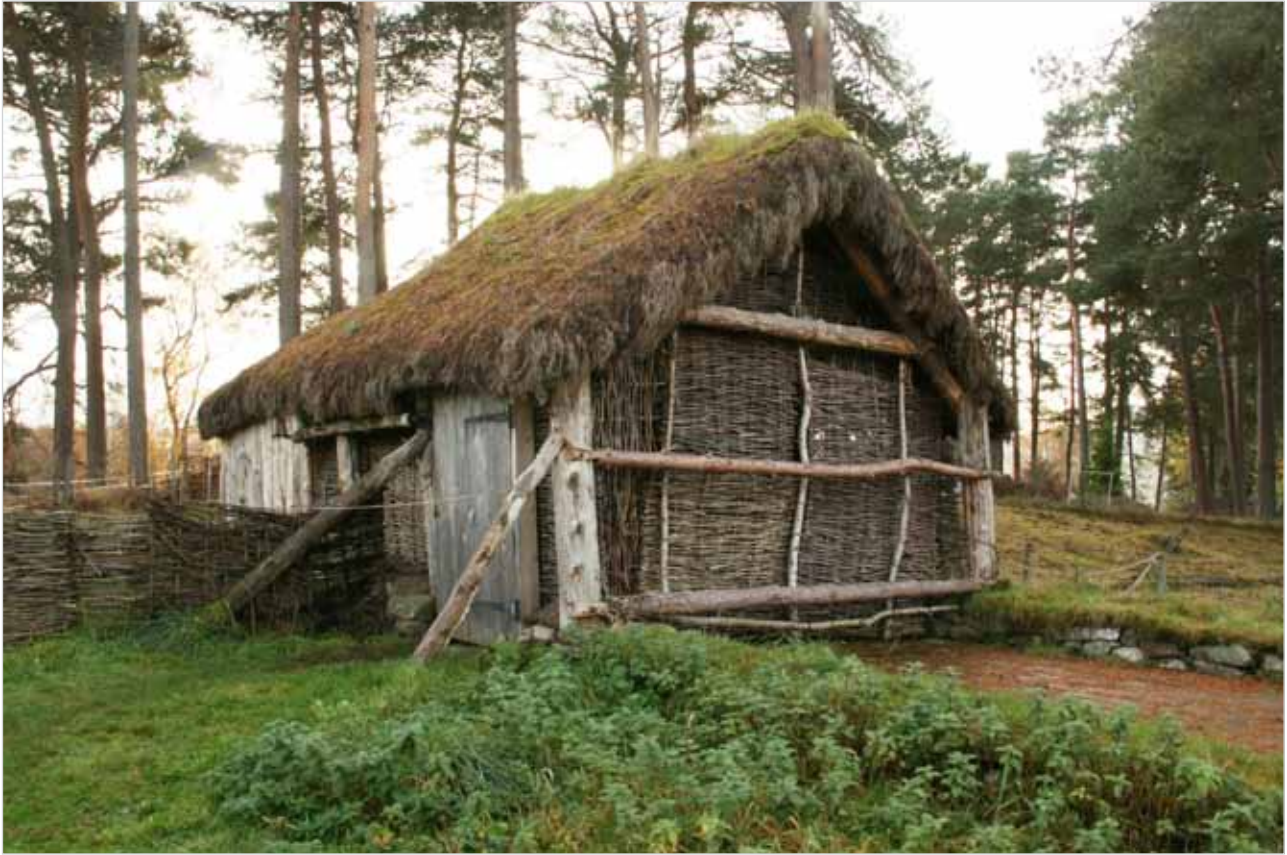
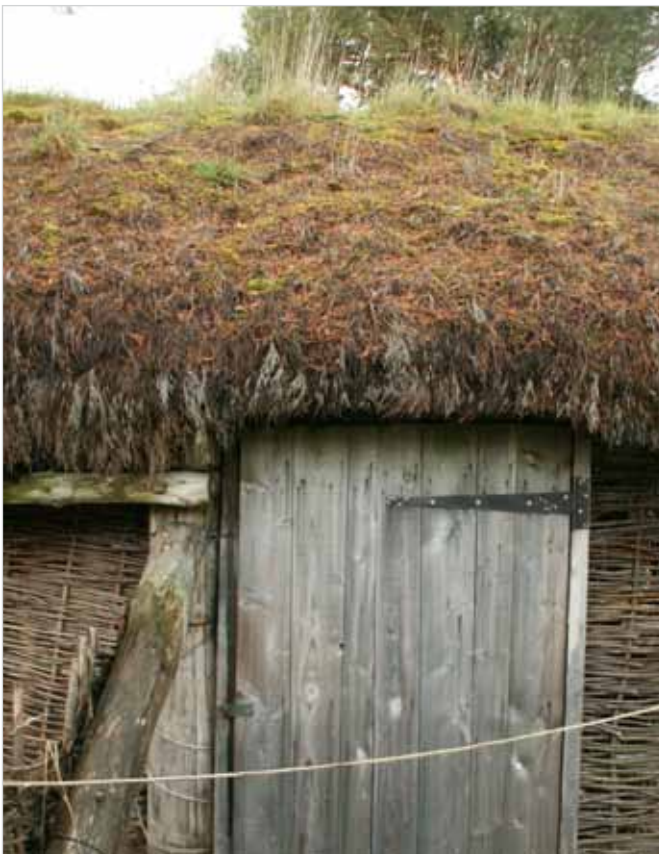
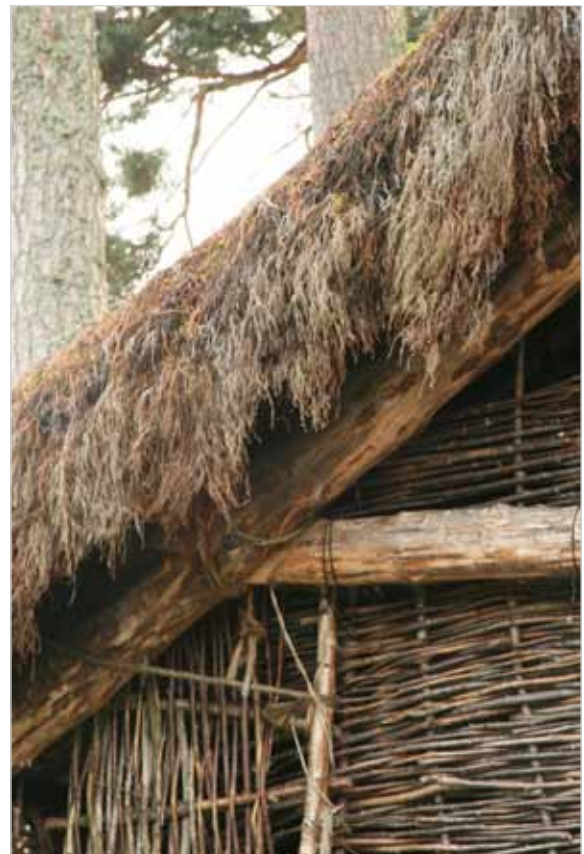
Cottar's House – Highlands

..... The thatched roof is of broom underneath a top coat of heather and has a turf ridge. The roof has been left uncovered and has a small amount of mossy vegetation growth throughout.

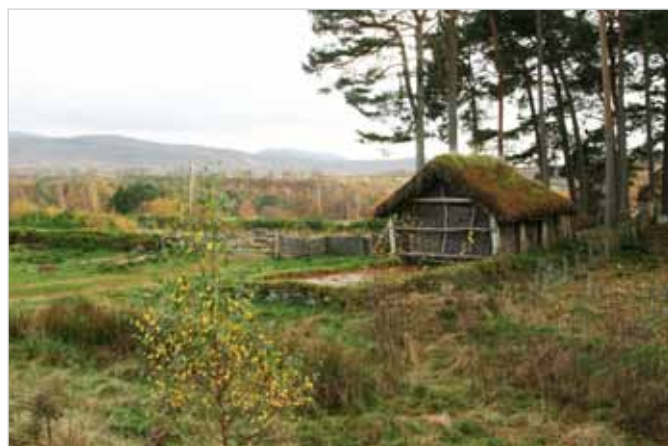
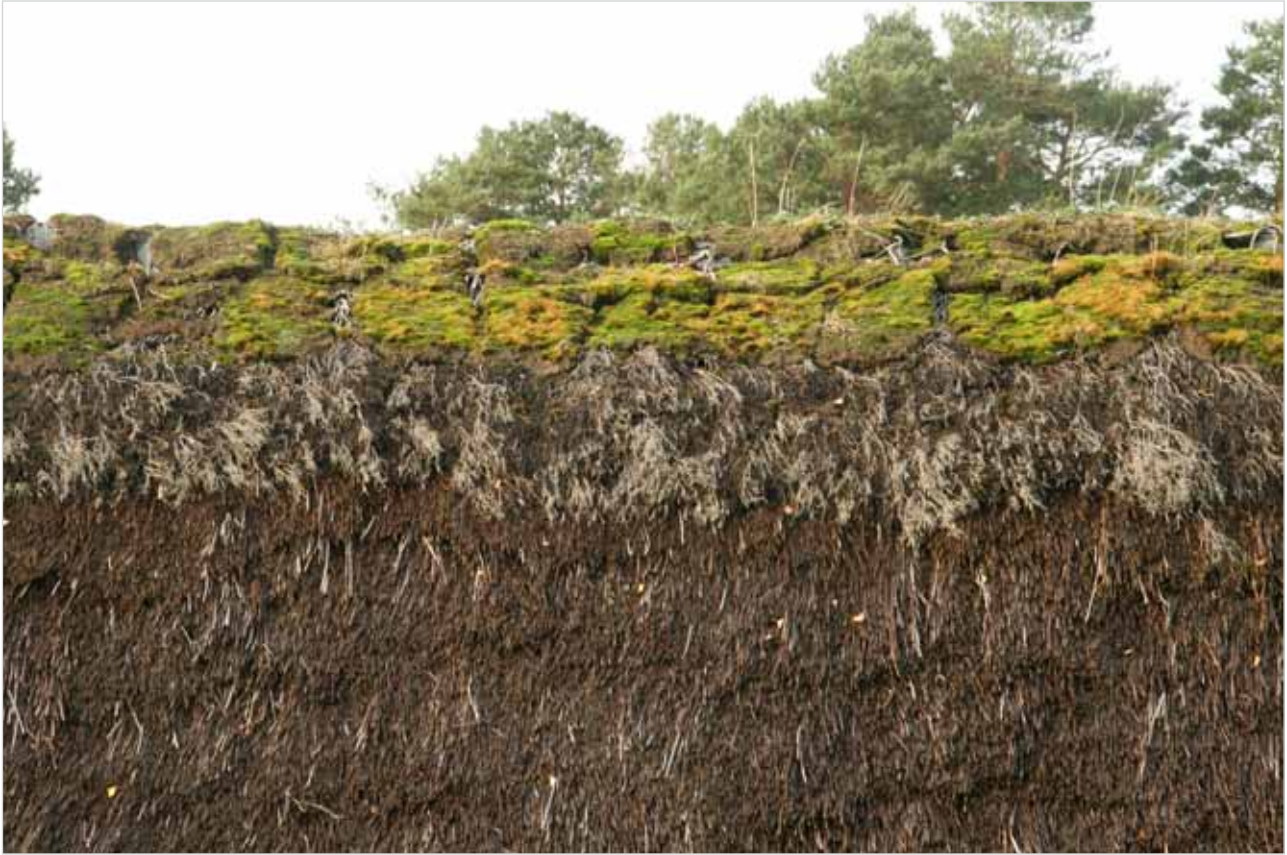
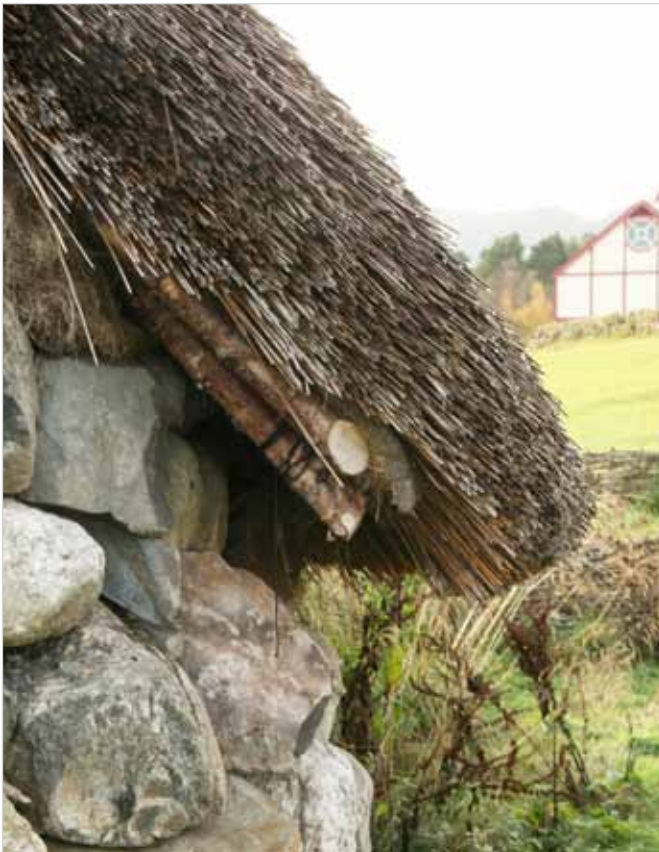
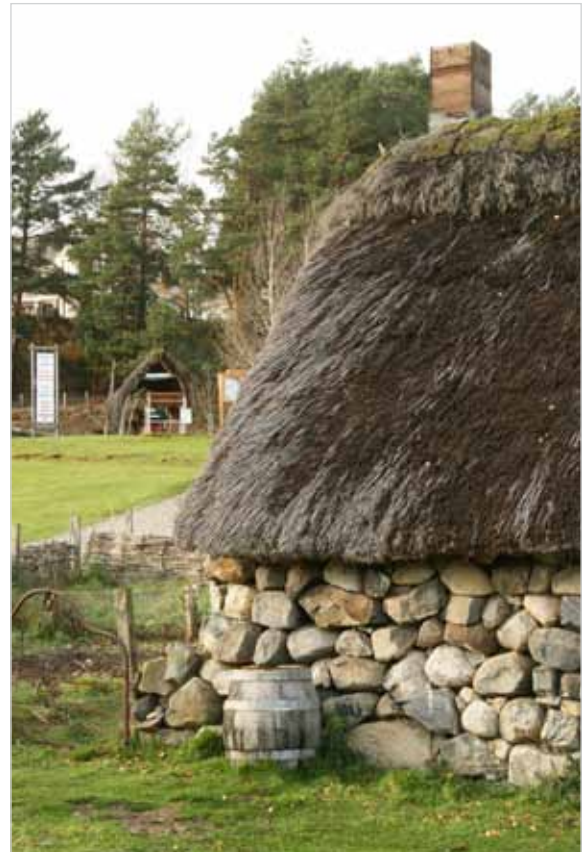
Disabled Toilet – Highlands

..... This building, constructed of timber, is used as an accessible toilet for visitors to the site. It has a heather thatch  
..... roof with a turf ridge. The entire roof has been left uncovered and allowed to flourish of its own accord. There is  
..... a small amount of mossy and grassy vegetation growth across the surface of the thatch.

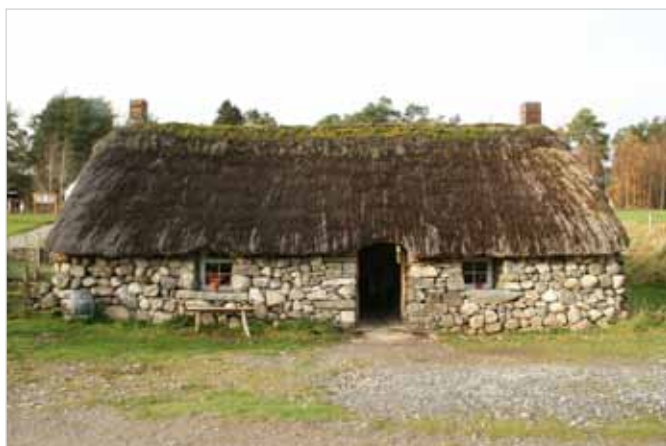
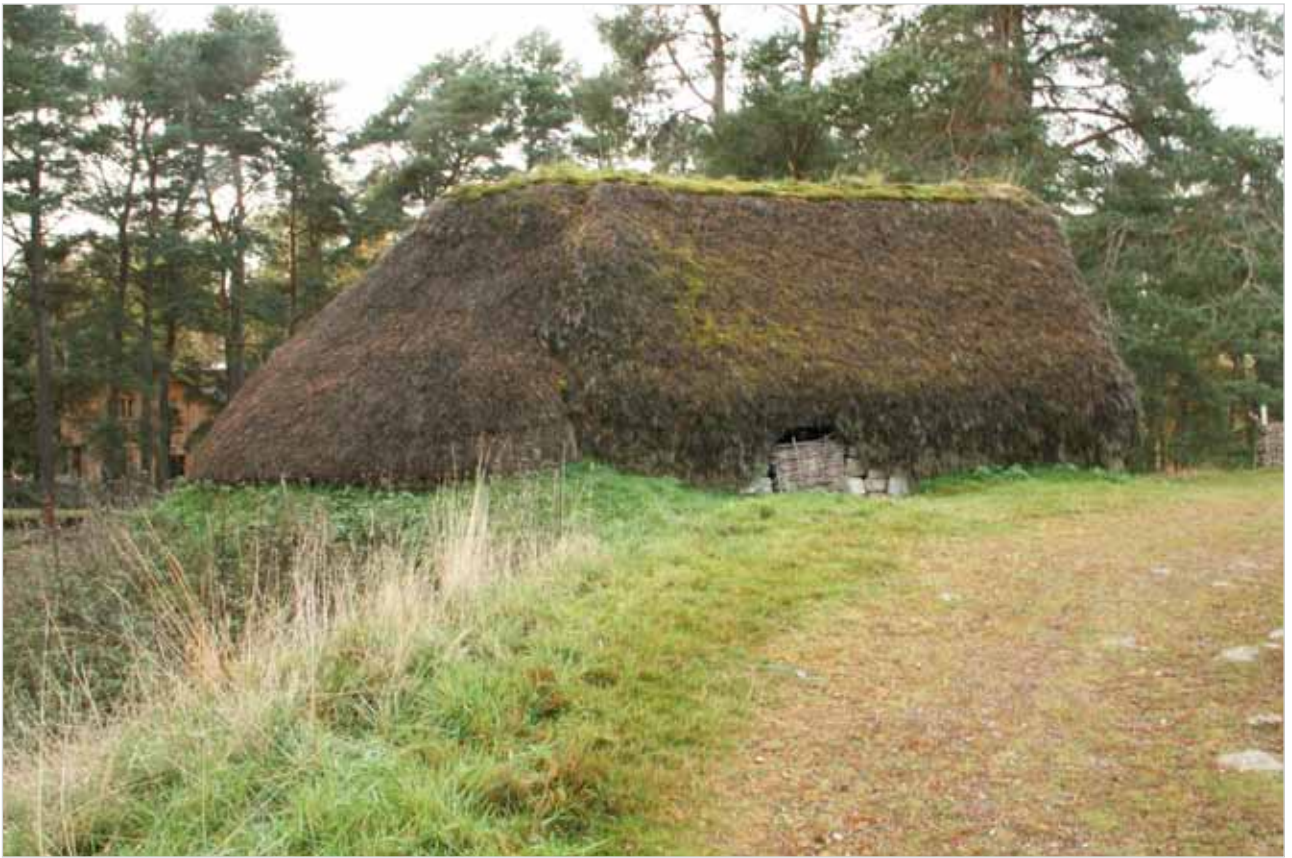
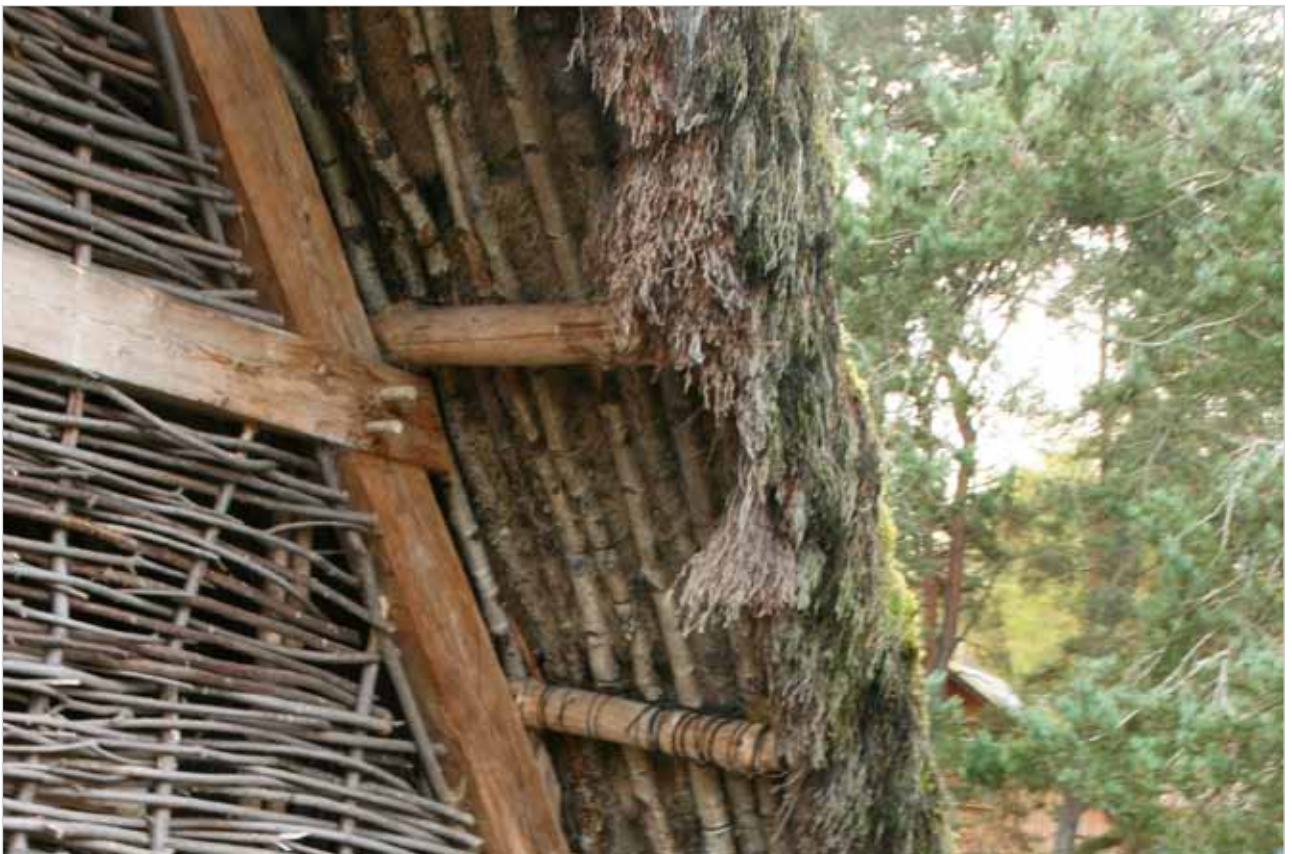
The Highland Cottage – Highlands

Additional Notes: ..... The building was inspired by a circa 1890 photograph of a Highland cottage in Grantown, recreated and interpreted for the same period. It is part of the Highland Folk Museum in Newtonmore, and according to the guidebook the house was 'probably "home" built in the early 1800s'. Also noted in the guidebook, the roof is described as being covered with 'cabers, turf and heather thatch'; however, the roof is currently thatched in what appears to be reed or straw, with a layer of heather underneath a layer of turf across the ridge. The entire roof has been left uncovered.

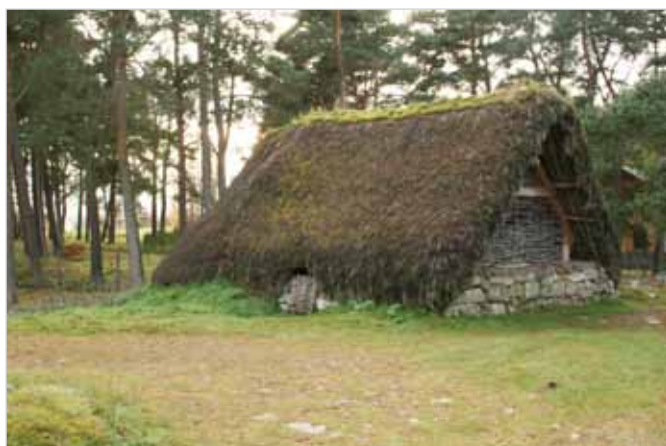
Kiln Barn – Highlands

mossy and grassy vegetation growth across the surface of the thatch. The eaves of the roof come down very low

and almost reach ground level.

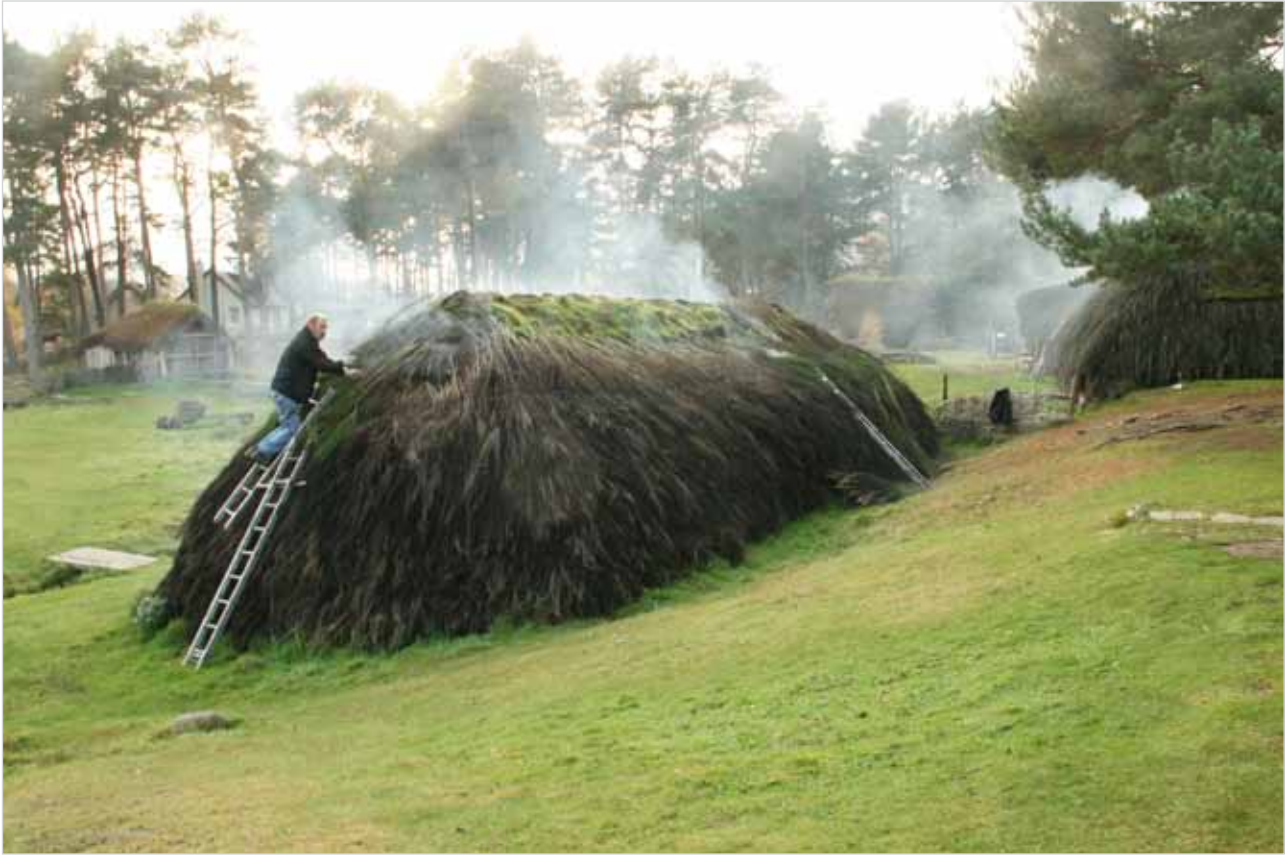
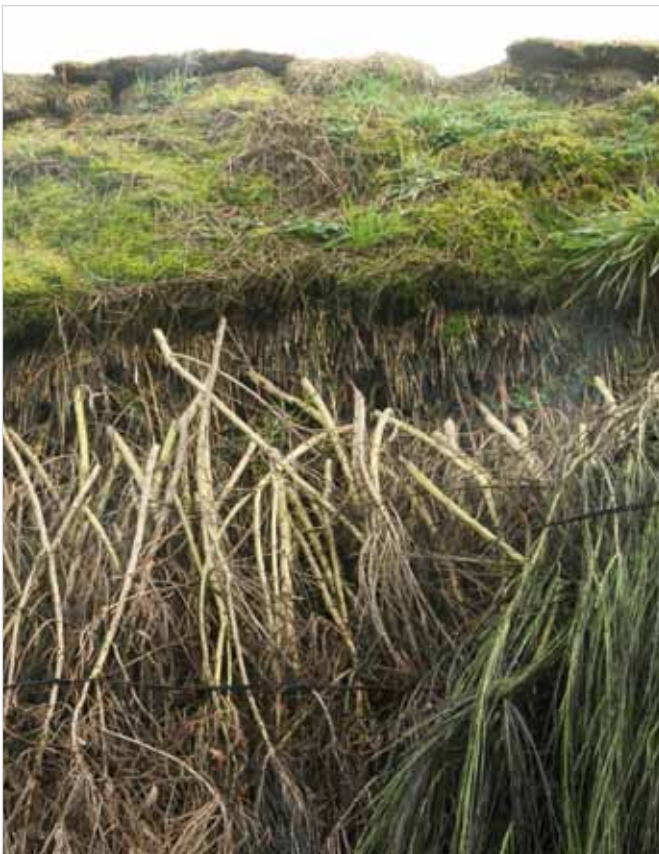
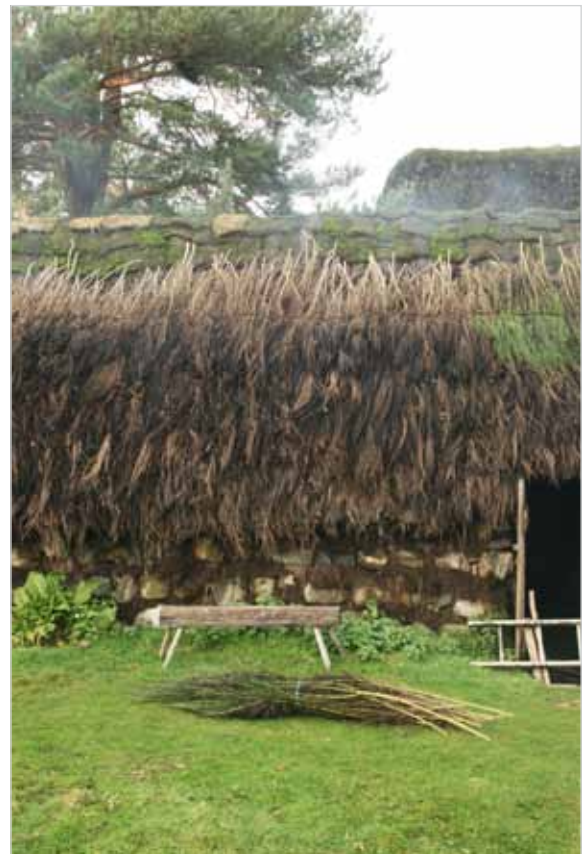
Stockman's House – Highlands

Condition of Thatch: ..... Good

..... The building was in the process of being re-thatched upon visiting by staff at the open-air museum. The roof is  
..... thatched in broom and has a turf ridge. The roof has been left uncovered. The thatch appears to be secured to  
..... the roof in bundles with string.

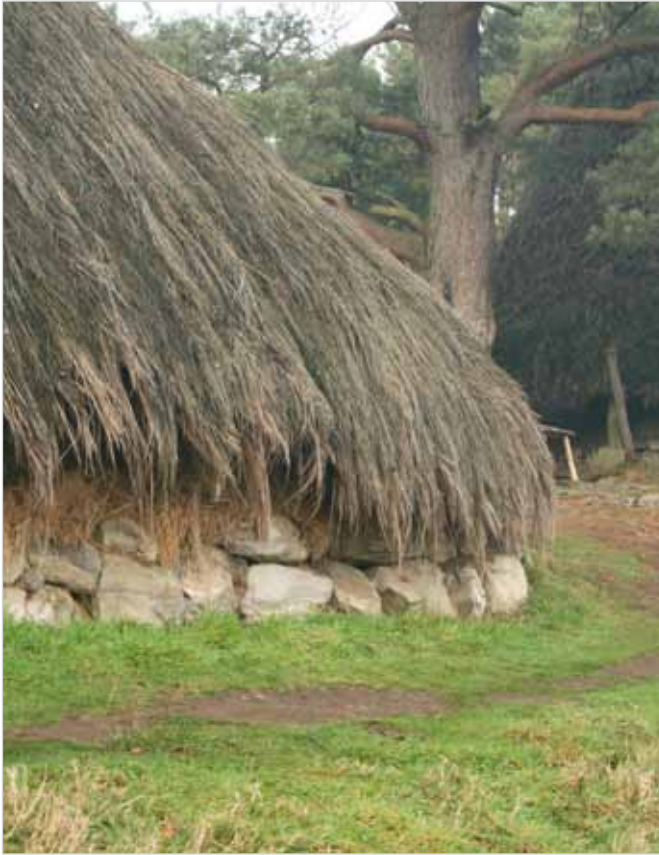
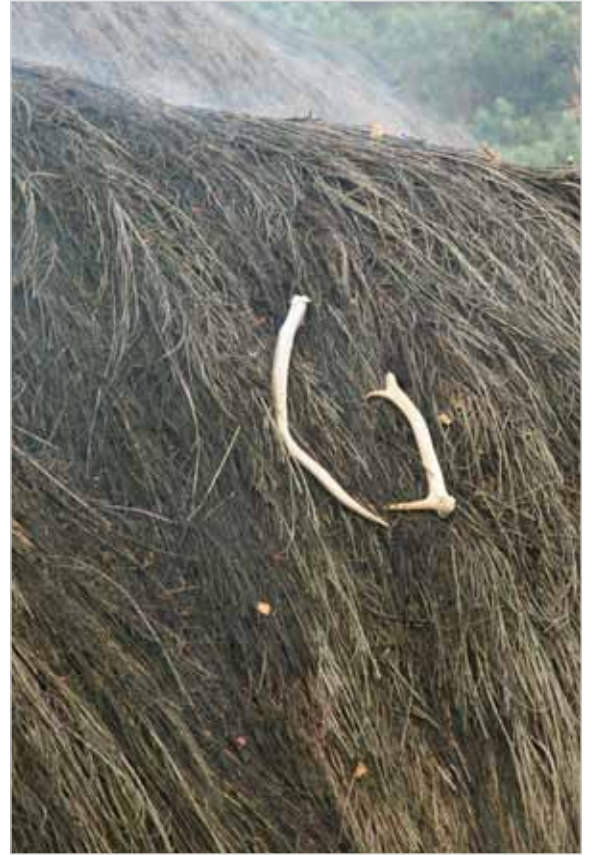
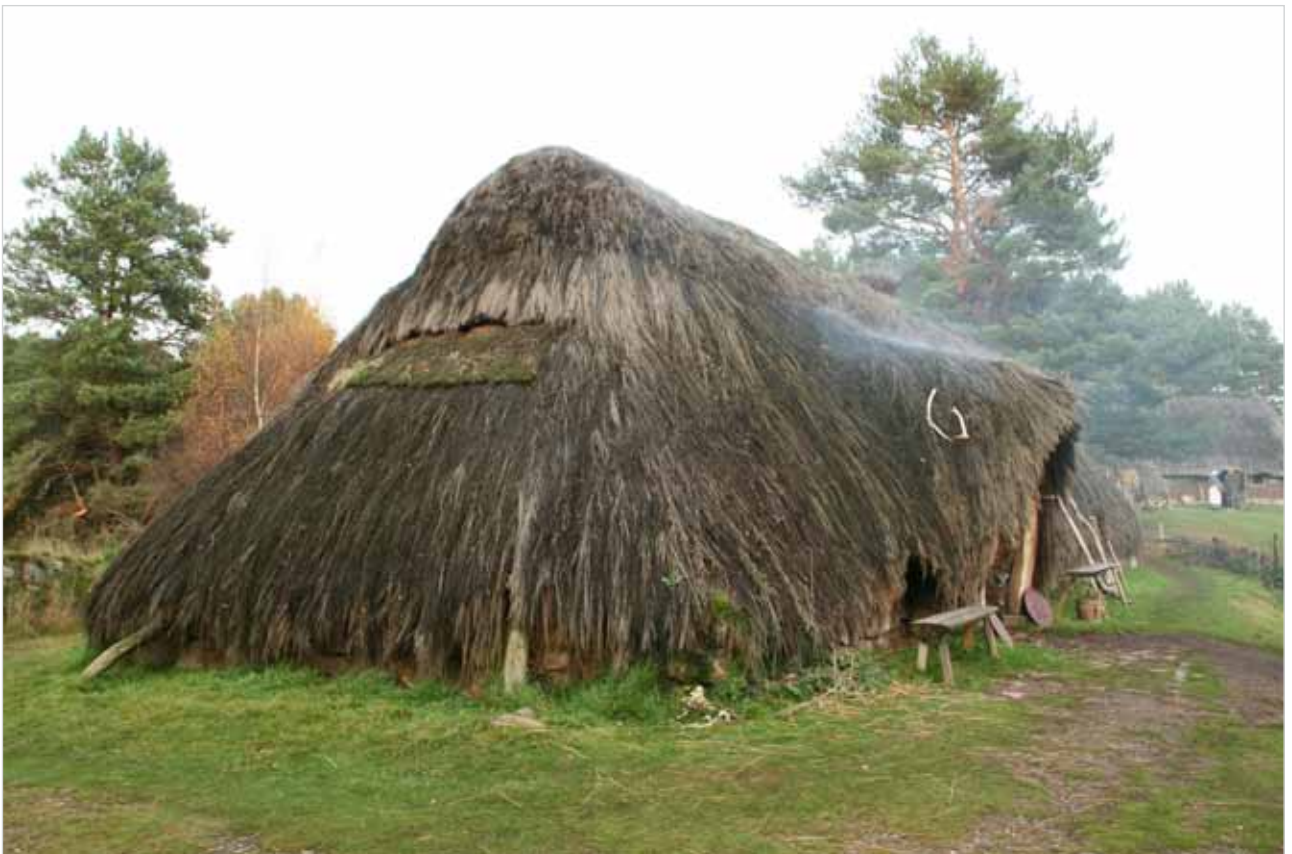
Tacksman's House – Highlands

Condition of Thatch: ..... Good

..... The roof is thatched with broom and has a turf ridge. There is also turf laid below an opening in the roof at the west end where smoke is allowed to exit the building. The broom has been left uncovered and the eaves come down low, close to ground level. Deer antlers have been tied decoratively to the thatch above the hooded door opening on the front elevation.

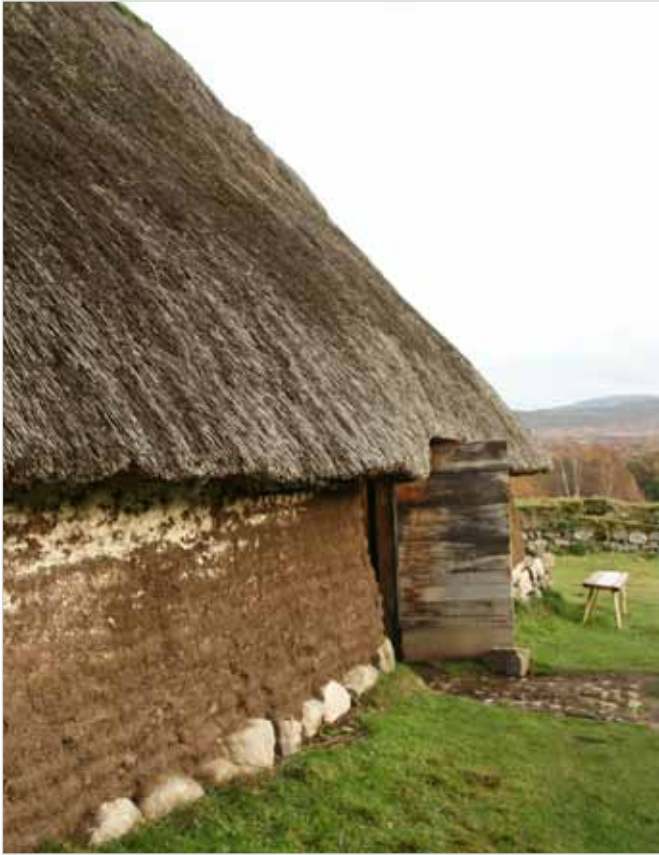
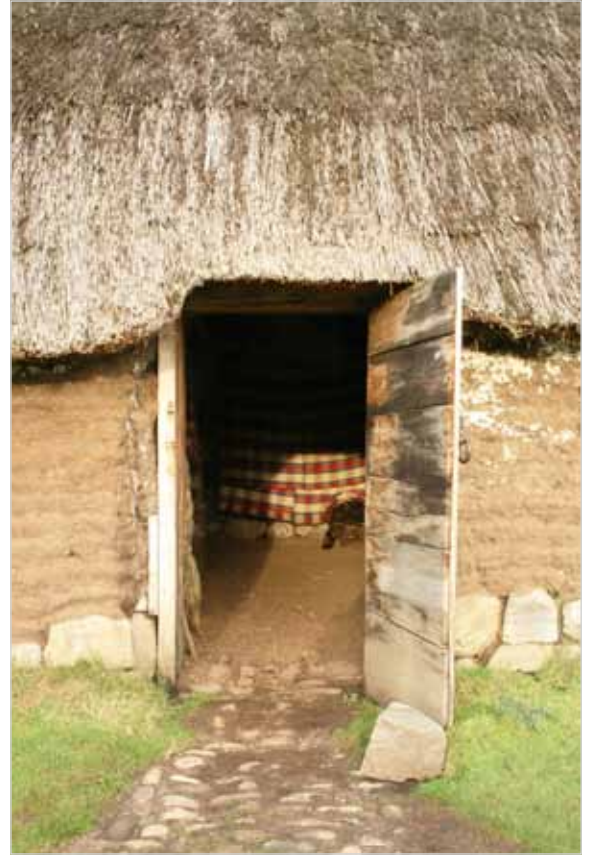
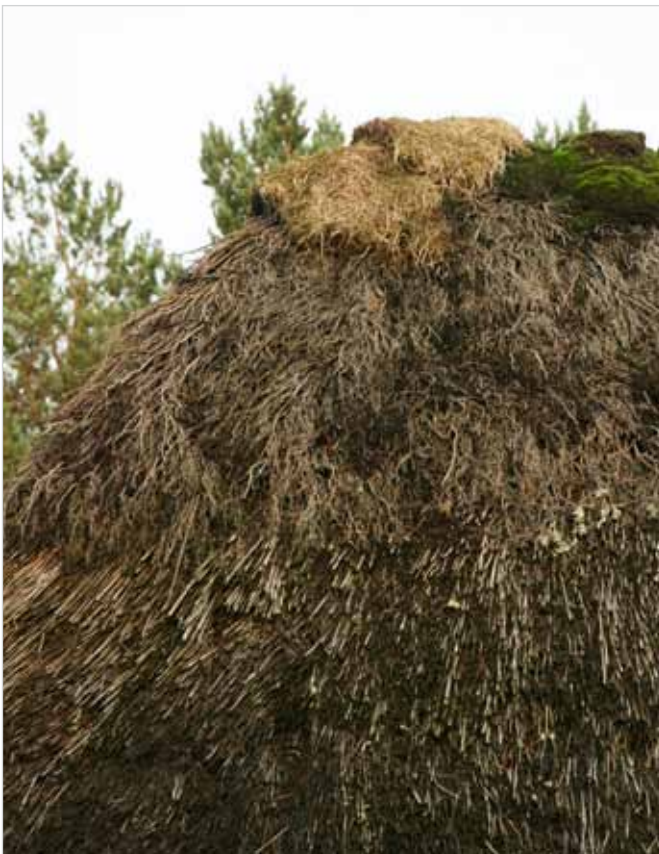
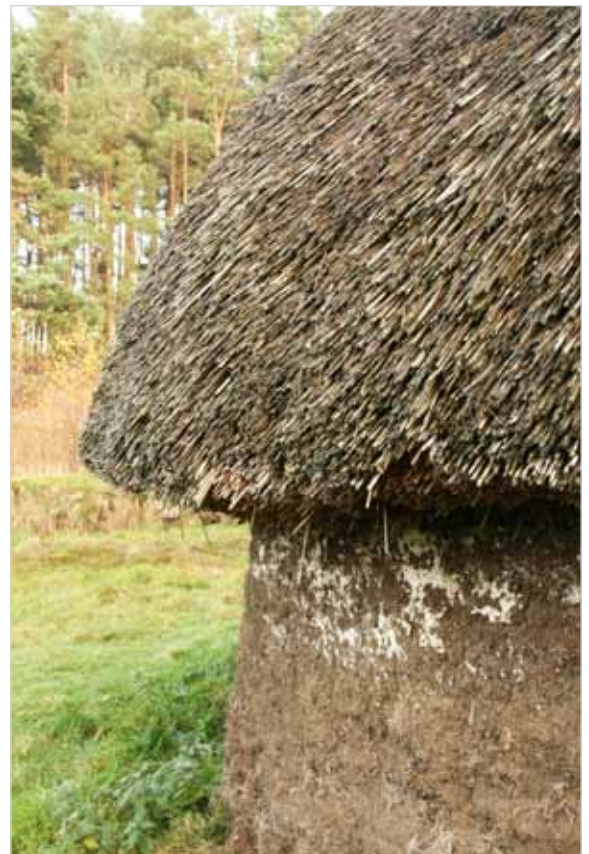
Weaver's House – Highlands

Condition of Thatch: ..... Good

..... The roof is thatched in reed and has a layer of heather underneath a layer of turf across the ridge. The roof  
..... has been left uncovered and has a small amount of mossy vegetation growth across the surface of the thatch  
..... throughout. The eaves of the roof end much higher than the other buildings in the reconstruction Township,  
..... whose roofs are thatched in a mixture of broom, bracken and heather.
